Potential induced degradation (PID): a test campaign at module level

J. Carolus^{1,2}, M. Daenen^{1,2}

1) Hasselt University, Martelarenlaan 42, 3500 Hasselt, Belgium

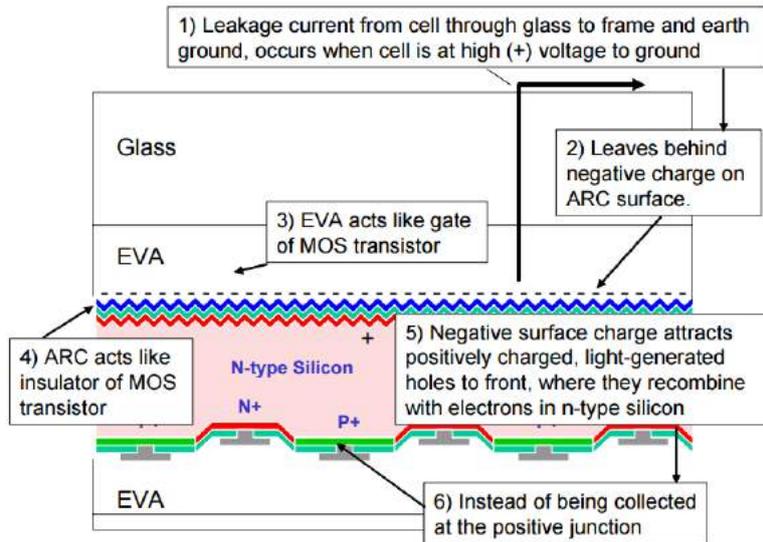
Figure 1: Cross-section of a back-contact solar cell with n-type passivation capped with a silicon dioxide, silicon nitride ARC. [4]

PID has been described as early as 2005 as the surface polarization effect by Swanson *et al.* [4] They described the degradation of Sunpower cells by high voltage stress (HVS) which is caused by a surface charge that is formed near the passivated front surface of a high efficiency back contacted n-type silicon cell as shown in Figure 1. In this case the degradation effect was very significant already at module voltages of +160 V. In this publication they already showed that this surface polarization effect can be found also in standard contacted cells. This effect was also shown to be reversible by applying a reverse bias and also by UV irradiation, which can remove the trapped surface charge.

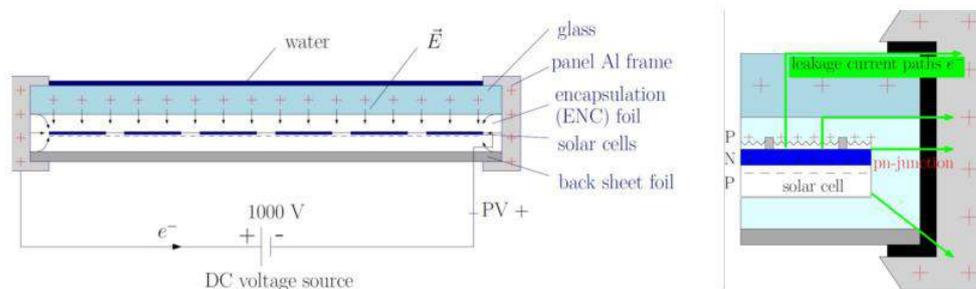
Figure 2: PID test setup and leakage currents as described by Pingel *et al.* [1]

In the paper by Pingel *et al.* [1] a similar degradation caused by HVS was described on p-type standard cells. Besides the precondition of having a PID sensitive cell they also showed ways to stop or minimize PID on panel and system level. According to them, PID depends on polarity and the level of the potential between the cell and ground. On panel level they describe the leakage currents in a lab PID setup as shown in Figure 2. As was already described, they also mention the possibility to recover the lost power by applying reverse potentials as shown in Figure 3.

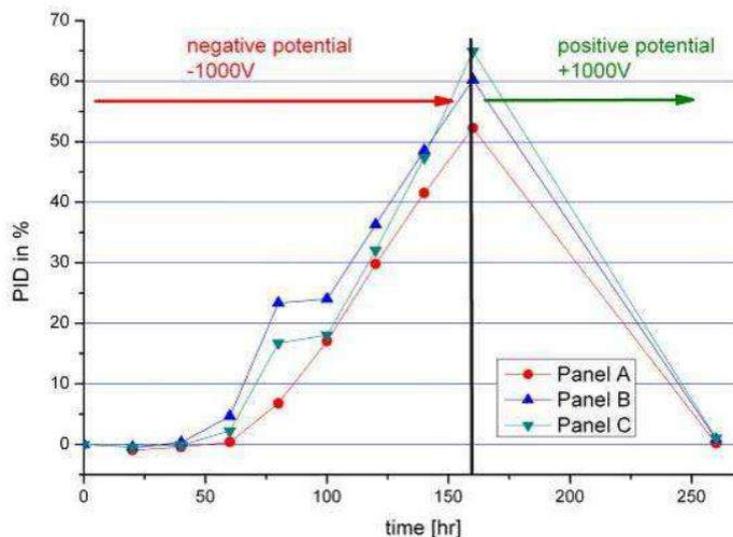
Figure 3: PID and recovery by reverse potential. [1]

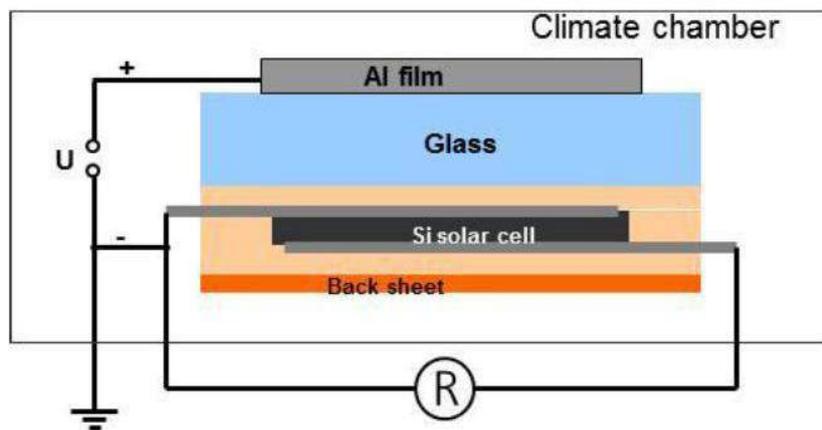
Figure 4: A simplified representation of the foil-method according to IEC 62804. [3]

Dietrich *et al.* reported on PID testing in 2012. [3] They conducted PID tests on 95 PV modules in different test conditions. The foil-method, which is schematically shown in Figure 4, was used to stress test 77 PV modules. This was done at 50 °C and 50 %RH for 48 hours. 11 PV modules were tested without the foil at a temperature of 60 °C and a relative humidity of 85 %. The remaining 7 modules were tested with the foil-method at 50 °C and 50 %RH for 168 hours. 46 % of the tested PV modules failed the 5 % loss criteria as stated by IEC 62804. They also described a scattered loss of power per module type of the same manufacturer.

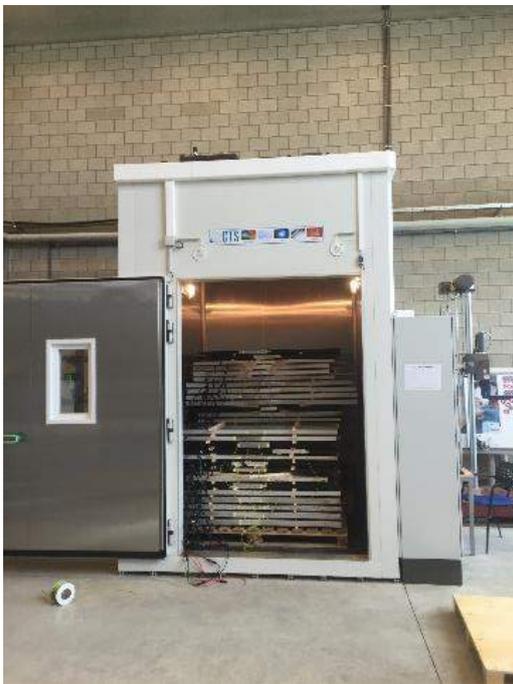
Figure 5: The climate chamber with the PV modules stacked for the PID stress test.

In order to apply a higher stress level to the modules, the proposed tests were combined; the modules were covered with an aluminium foil and stressed for 96 hours inside a climate chamber (a CTS, CW-40/19) at $60\text{ °C} \pm 2\text{ °C}$ and $60\text{ \%RH} \pm 5\text{ \%RH}$. This setup is shown in Figure 5. A voltage difference of 1000 V between the cells, from which the negative and the positive output were short circuited, and an aluminium foil was provided by an Ultravoltage BT-GP-1P30 voltage source. Figure 6 shows the aluminium foil covering the front surface of the modules.

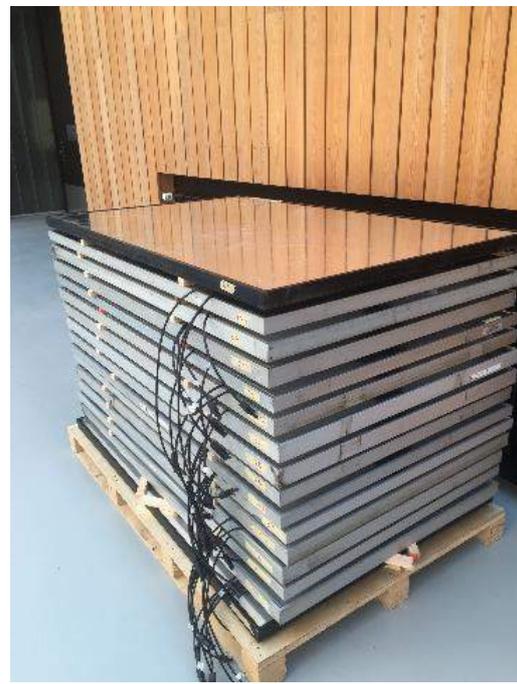
Figure 6: Some of the PV modules prepared with an aluminium foil

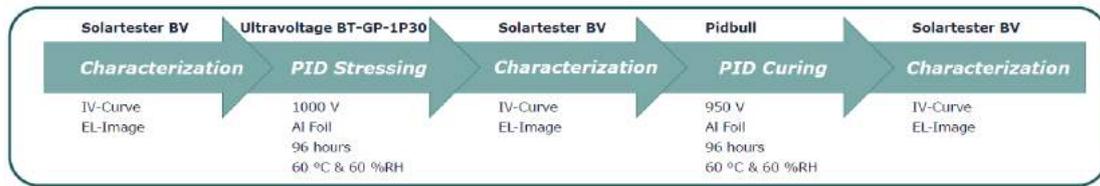
Figure 7: A flowchart which represents the working method to characterize, stress and recover the modules for PID.

A mobile lab of Solartester BV carried out the characterization of the modules. A flash test and EL-image of the modules were obtained before the stress test, after the stress test and after the recovery period. Note that the outcome of an IV curve is a quantitative representation of PID, while an EL-image is only a qualitative representation for PID. The process of characterization, stressing and recovering the modules for PID is presented in Figure 7.

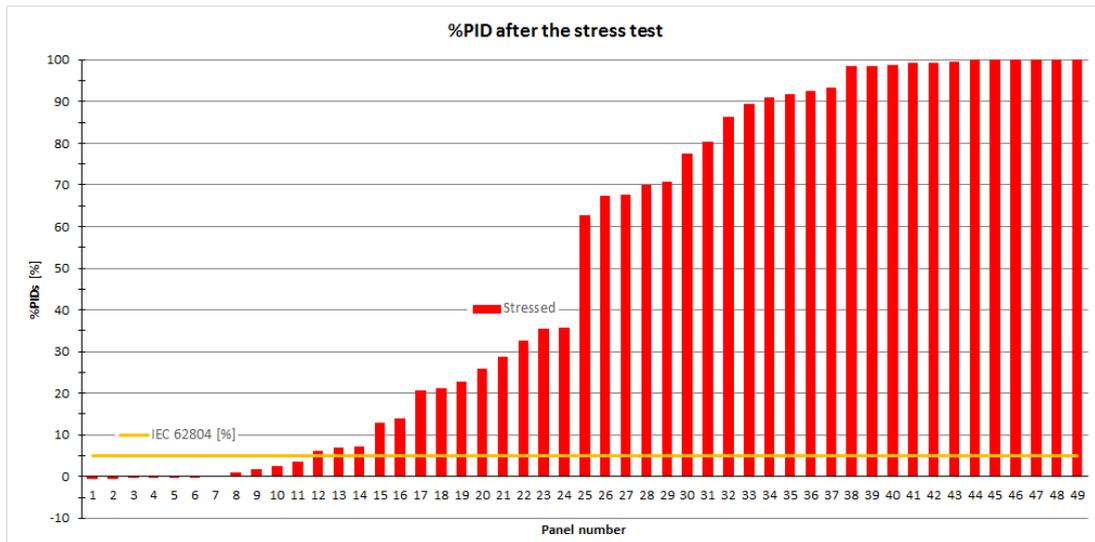
Figure 9: The %PID_s of the 49 PV modules after stressing as well as the 5 % loss criteria according to the IEC 62804 standard.

After stress testing the PV modules for PID during 96 hours at the previously mentioned conditions, only 22 % passed the 5 % loss criteria, as stated by IEC 62804. Note that the stress level applied to these panels exceeds the stress level proposed by the standard in progress. Figure 9 displays the %PID_s of the 49 PV modules subjected to the stress test together with the 5 % limit to pass the PID test.

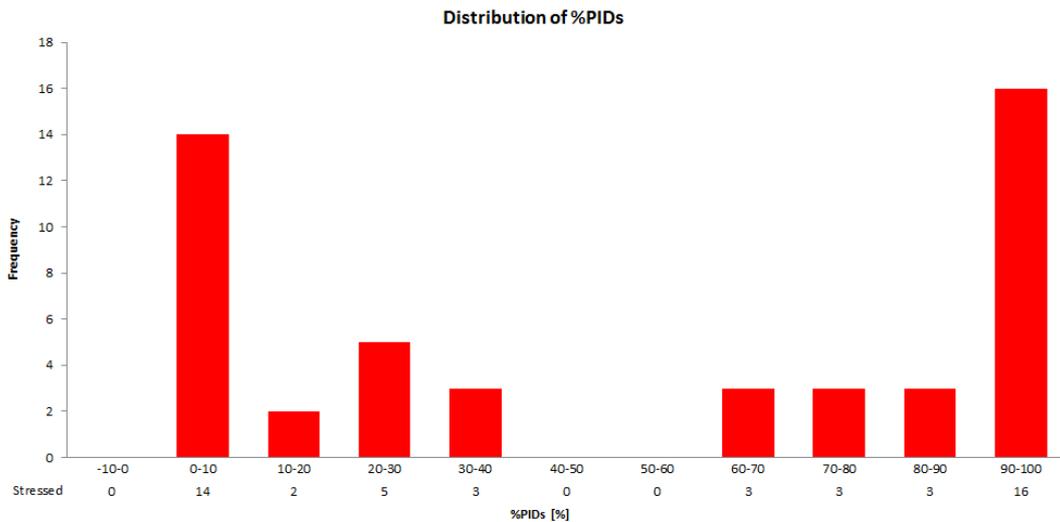
Figure 10: The distribution of stressed PV modules in function of %PID_s.

The distribution of stressed PV modules in function of %PID_s is shown in Figure 10. This histogram shows that 19 out of 49 stressed PV modules are degraded more than 80 % by PID. Only 16 out of 49 modules have a %PID_s of less than 20 % after the stress test. Note that the %PID_s for a few PV modules had a negative value. However, since these values were very small (<1 %), it can be stated these results were obtained due to measurement errors.

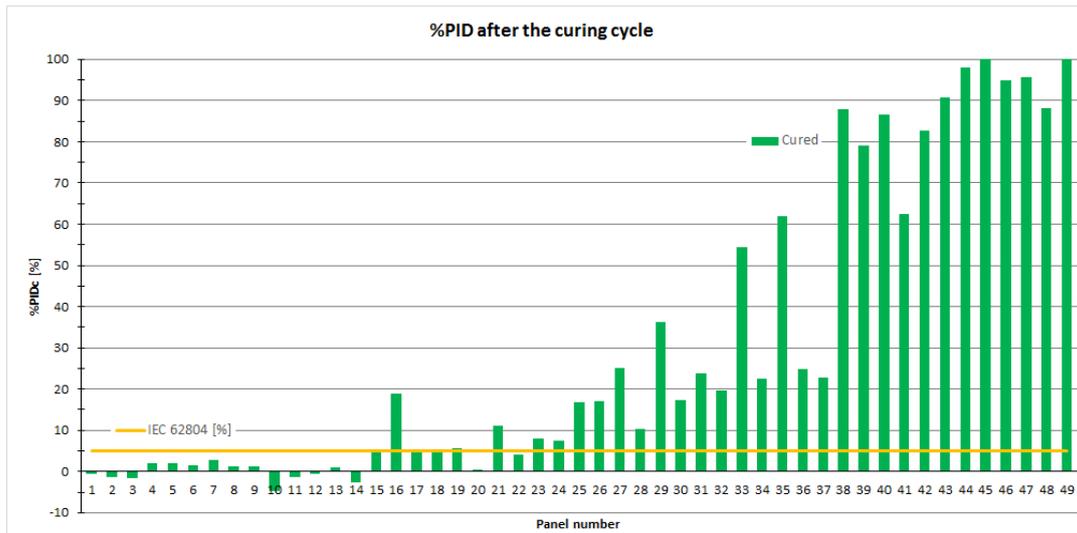
Figure 11: The %PID_c of the 49 PV modules after curing as well as the 5 % loss criteria according to the IEC 62804 standard.

After recovering the PV modules with pidbull for 96 hours at previously mentioned conditions, 37 % of the PV modules passed the 5 % loss criteria, representing an increase of 15 %. As previously mentioned, the voltage of the curing cycle was about 50 V lower than the stress cycle. The %PID_c after recovery is shown in Figure 11 together with the 5 % limit to pass the PID test.

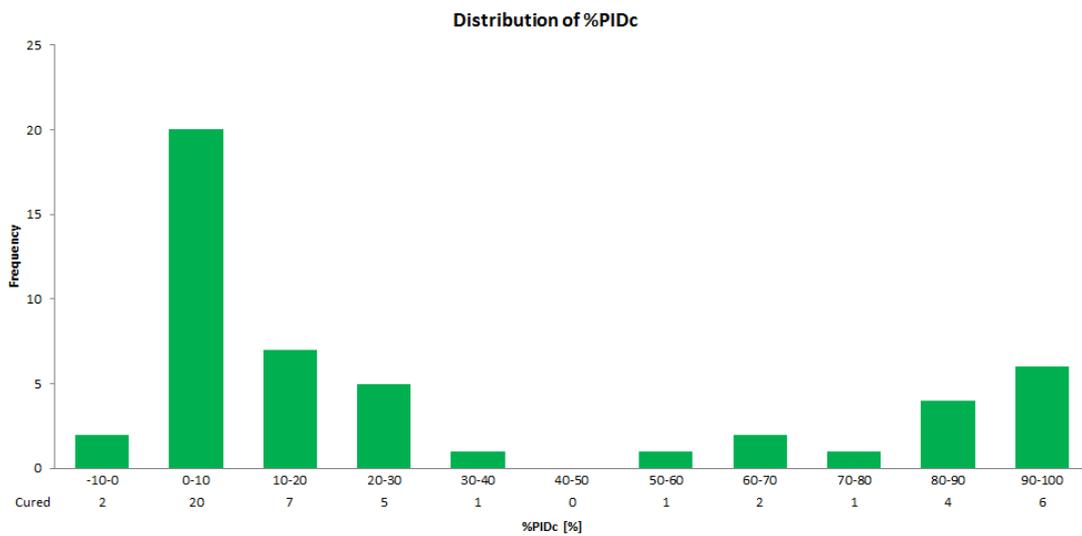
Figure 12: The distribution of cured PV modules in function of %PID_c.

The distribution of cured PV modules in function of %PID_c is shown in Figure 12. This histogram shows that only 10 out of 49 modules still have a %PID_c level of more than 80 % (in comparison to 19 out of 49 modules after the stress test). Furthermore, 29 out of 49 stressed PV modules are cured to a %PID_c of less than 80 % (in comparison to 16 out of 49 after the stress test). Apart from measurement errors, two modules tend to be recovered more than they were stressed. An overall recovery by pidbull is shown clearly.

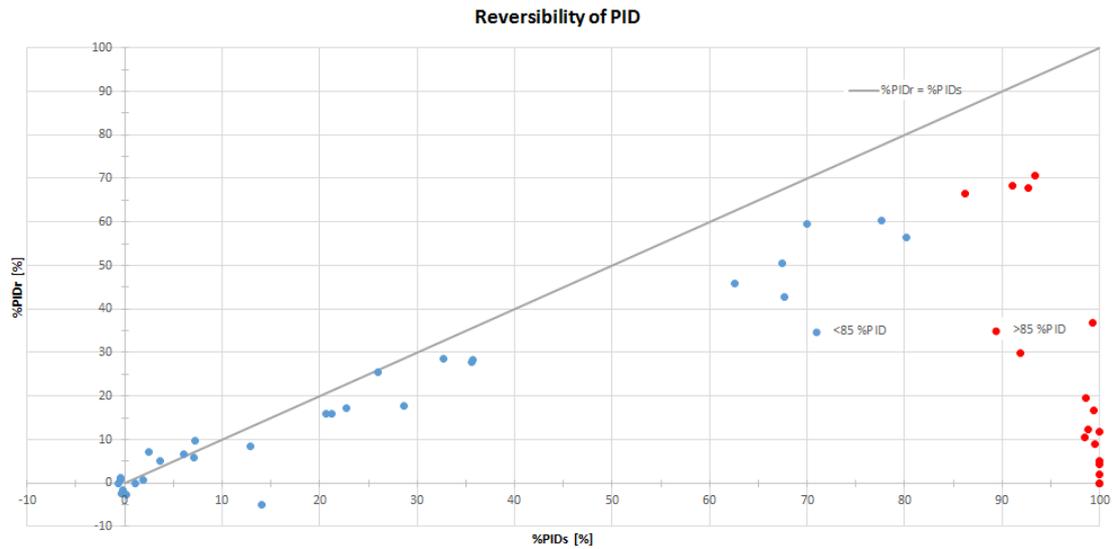
Figure 13: The reversibility of PID. Two different degradation mechanisms can be distinguished, clarified with blue and red data points.

When %PID_R is plotted in function of %PID_S, as shown in Figure 13, two different degradation mechanisms can be distinguished. An overall linear trend can be seen with a %PID_S of less than 85 % (blue points). However, some modules with a %PID_S of more than 85 % (red points) seem to recover slower or, in worst case, don't recover at all. This phenomenon is already mentioned by Koch *et al.* [12] Further research has to be conducted to look into the mechanism which causes this irreversible form of PID at higher %PID_S. The modules which are located at the left side of the bisector (grey line) tend to be recovered more than they were stressed. Note that no intermediate measurements were conducted during recovery.

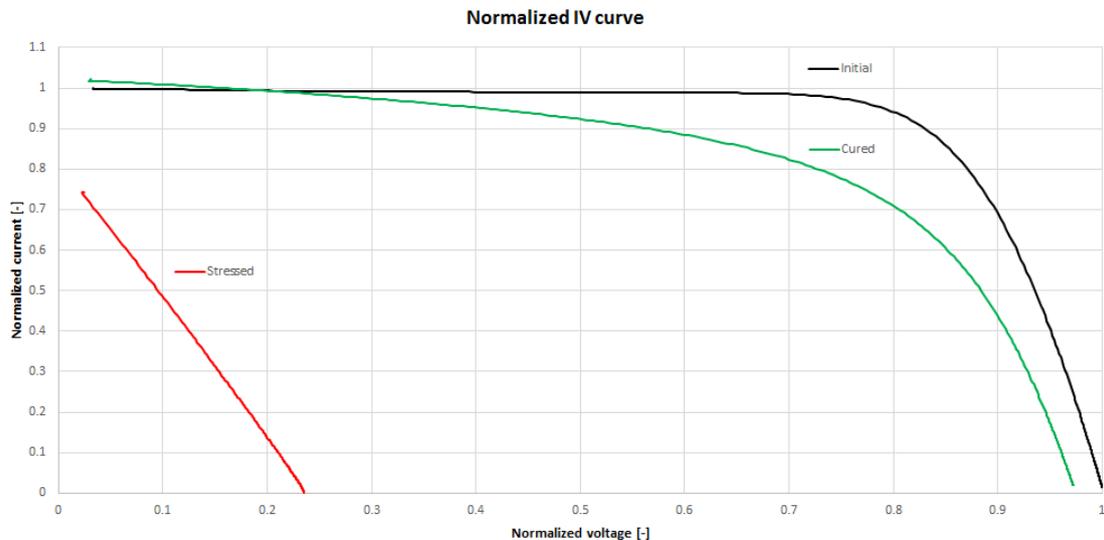
Figure 14: The normalized IV curves of one PV module after the 3 tests. The maximum output power of this module degraded for 93 % due to PID. By connecting it to pidbull, only 22 % of the degradation due to PID was still present.

The normalized IV curves of one PV module after every test are shown in Figure 14. The black line in this graph shows the IV curve of the module after the initialization test. The red line shows the IV curve after the stress test. At this point, the maximum power point of the module was degraded by PID for 93 %. The green line shows the IV curve after the recovery cycle. Pidbull was able to recover the maximum power point of this module and only 22 % of the degradation due to PID was still present after the recovery cycle.

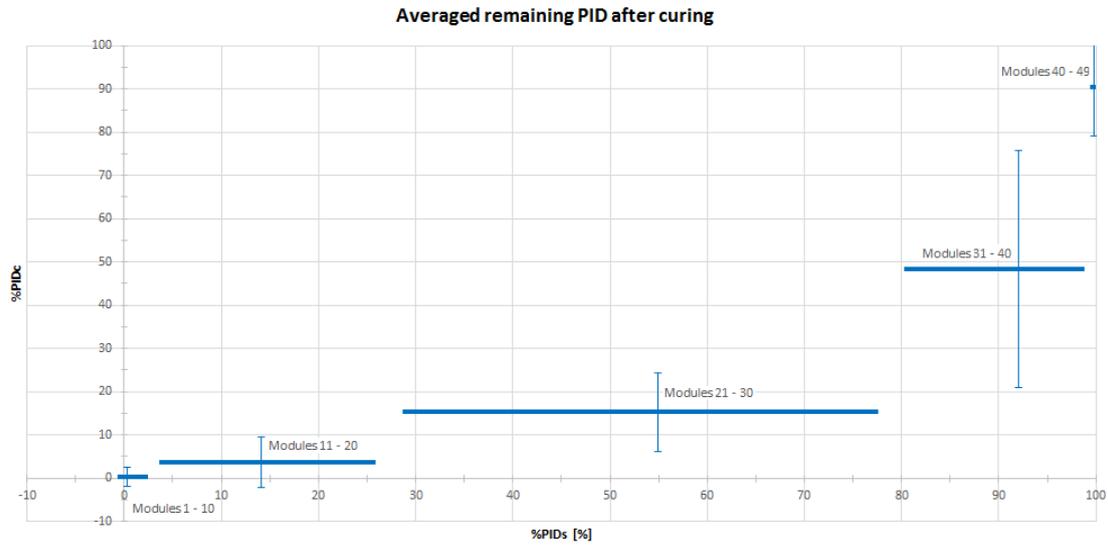
Figure 15: The remaining power after curing (%PID_c), averaged over 10 PV modules, in function of %PID_s. The horizontal bars represent the range of the %PID_s of the selected group whereas the vertical bars represent the standard deviation.

A plot of $\%PID_R$, averaged over 10 modules, in function of $\%PID_S$ is shown in Figure 15. The horizontal bars represent the range of the $\%PID_S$ of the selected group of PV modules. The vertical bars represent the standard deviation of the $\%PID_C$ of the selected group. For this purpose, the set of 49 PV modules was divided in five groups. Every group represents 9 or 10 modules in the same sequence as used before. The first group (module number 1 – 10) includes degradation ratios ranging from -0.5 to 2.5 $\%PID_S$. The average degradation for this group is $< 1\%$. On average, this group of 10 PV modules was degraded by PID for only 0.2 % after the recovery cycle. The second group covers degradation ratios ranging from 4 to 26 $\%PID_S$ with an average of 14 $\%PID_S$. This set of modules had an average of 3.5 $\%PID_C$ after recovery. The next group covers a range from 29 to 77 $\%PID_S$ with an average of 55 $\%PID_S$. After curing, this group had on average 15 $\%PID_C$ left. The data points of the last two groups include mainly degradation ratios of $> 85\% \text{PID}_S$. As already discussed for PID stress levels $> 85\%$, an

irreversible degradation is observed. Group 4 covers a range from 80 to 99 %PID_s with an average value of 92 %PID_s. On average, this group had 48 %PID_c left after the curing cycle. The last group of (9) PV modules includes %PID_s values ranging from 99 % to 100 %. On average, this group had 90 %PID_c left after recovery. This graph highlights the importance of detecting PID in an early stage in order to recover it to an acceptable level.

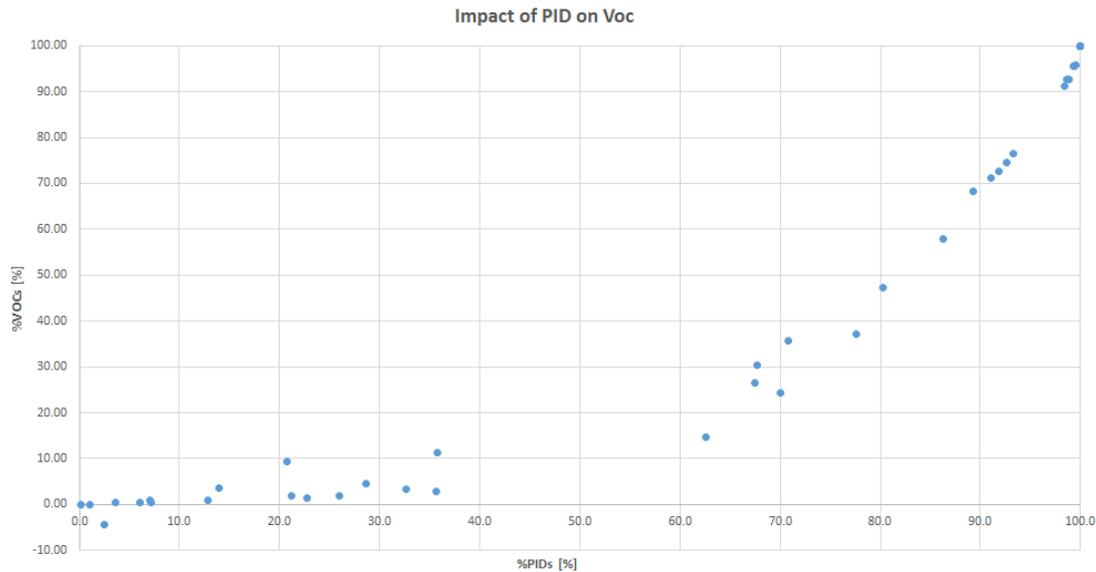
Figure 16: Plot of the %Voc5 in function of %PID5. The Voc only degrades significantly for higher PID levels (40 % or more).

When the %V_{OCS} is plotted in function of the %PID_s, a clear trend can be seen as shown in Figure 16. However, only PV modules with a high degradation level due to PID can be recognized by a degradation in V_{OC}. The V_{OC} doesn't degrade significantly until %PID levels of 40 % or higher are reached. Martínez-Moreno *et al.* [15] reported on the dependency of the V_{OC}. He concluded no significant changes for low %PID_s as well.
